Access Rider Duppy Hunter – A local’s guide to St Pauls

### **General information regarding accessibility of the route.**

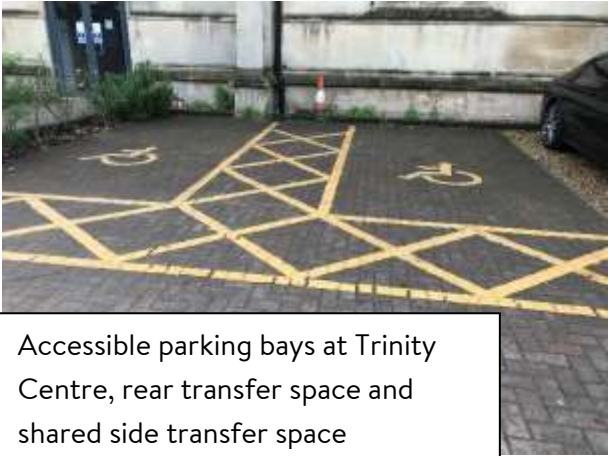
Location	Details	Images
<p>Trinity Centre</p> <p>Access by Car/Drop off</p> <p>Access by Bus</p> <p>Access for Pedestrians</p>	<p>Trinity Rd, St Jude's, Bristol BS2 0NW</p> <p><a href="https://www.trinitybristol.org.uk/contact/parking">https://www.trinitybristol.org.uk/contact/parking</a></p> <p>Two accessible parking bays. Blue Badge holders must pay for parking. Fines for overstaying. There is free on street parking available for Blue Badge Holders on Stapleton Road and Old Market (3hrs maximum)</p> <p>Main buses along Stapleton Rd are 48 and 49</p> <p>The main entrance from Trinity Road is also the main vehicle entrance there are no designated pedestrian walkways. The entrance is a steep slope as you reach the pavement the surface is very uneven with broken concrete.</p>

<p>Accessible parking bays at Trinity Centre, rear transfer space and shared side transfer space</p>

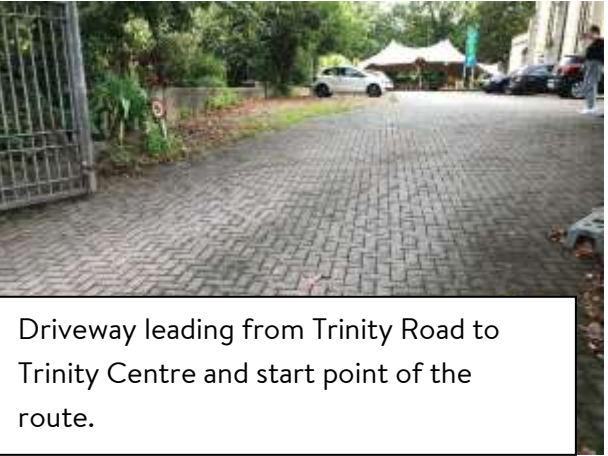
<p>Driveway leading from Trinity Road to Trinity Centre and start point of the route.</p>

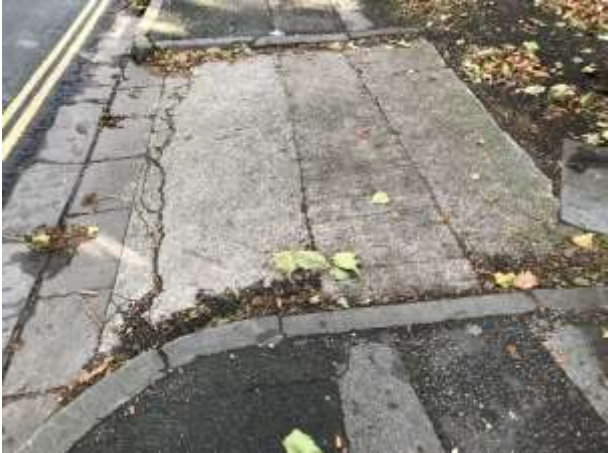
<p>Trinity Road</p>	<p>Uneven tarmac pavement, you cross a driveway with no tactile indicators and the kerbs are not fully flush.</p> <p>Option to use the zebra crossing, which takes you across Trinity Road and then across to Stapleton Road walking on the same side as Malik's. The crossing has tactile indicators and is flush.</p>

<p>Driveway on Trinity Road, no tactile indicators, not fully flush kerbs and uneven surface.</p>
<p>Stapleton Road</p>	<p>Possible waste bins on the pavement causing obstruction and restricting the width of the path. The left side (Malik's side) pavement has fewer obstructions. There is a crossing point with dropped kerbs and tactile indicators but this is not a zebra crossing or light controlled crossing.</p>

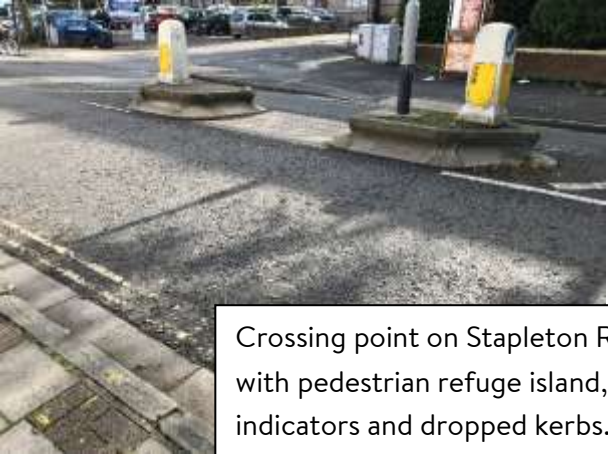
<p>Crossing point on Stapleton Road with pedestrian refuge island, tactile indicators and dropped kerbs.</p>

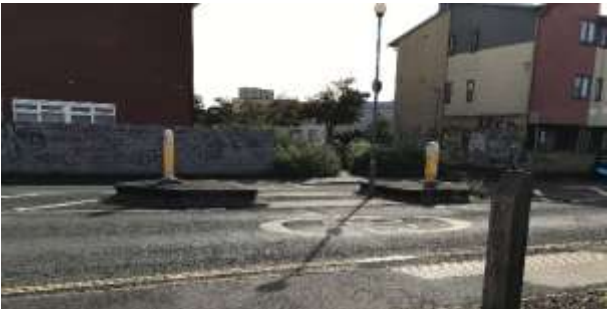
<p>Crossing Point from Pennywell Road to Peel Street, dropped kerbs, tactile indicators and pedestrian refuge island.</p>

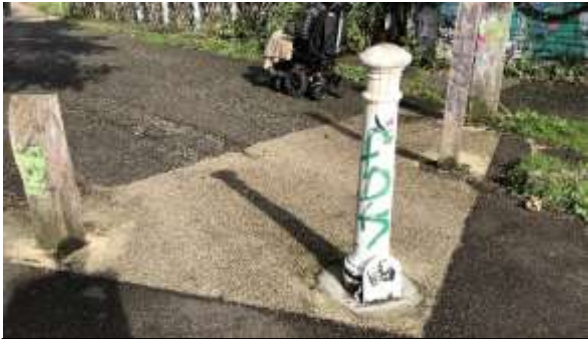
<p>Peel Street</p>	<p>Slopes downwards towards the bridge, there are bollards as you approach the bridge, which are wide enough to enable large scooters and electric wheelchairs to pass through.</p>

<p>Bollards at the end of Peel Street approaching the bridge to Riverside Park</p>
<p>Bridge over Danny</p>	<p>Tarmac has worn in places leaving an uneven surface. Immediately after the bridge is a cycle path. There are no tactile indicators or visual warnings indicating the cycle path, cross with care.</p>	
<p>Riverside Park</p>	<p>Uneven worn tarmac path that slopes up towards the M32 bridge. There are no level rest areas or benches.</p>

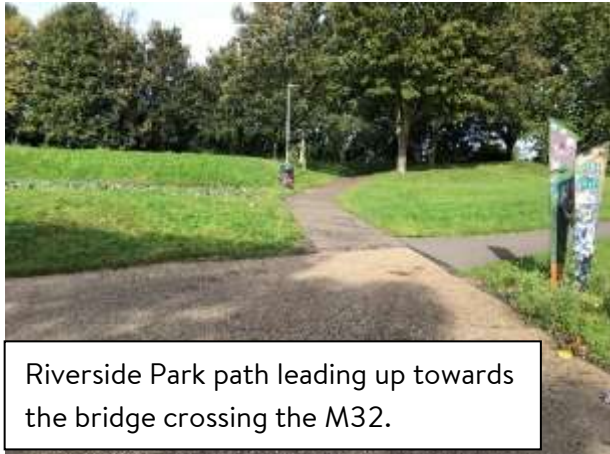
<p>Riverside Park path leading up towards the bridge crossing the M32.</p>

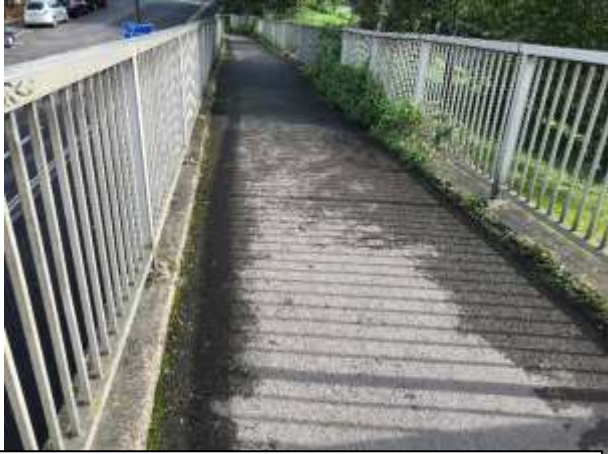
<p>M32 Bridge</p>	<p>Steep incline up and over the bridge. Tarmac surface, please be aware that this is also used by cyclists no pedestrian or cycle path indicators. The bridge has lots of traffic noise as it crosses the M32.</p> <p>Steep ramp leads down to Newfoundland Road on the right as you exit the bridge.</p>

<p>Steep ramp leading to Newfoundland Road from the M32 Bridge.</p>
<p>Newfoundland Road</p>	<p>No pedestrian crossing along Newfoundland Road. There are dropped kerbs with tactile indicators these are not fully flush with the road. The road is very wide but is one way with traffic coming from the left only.</p>

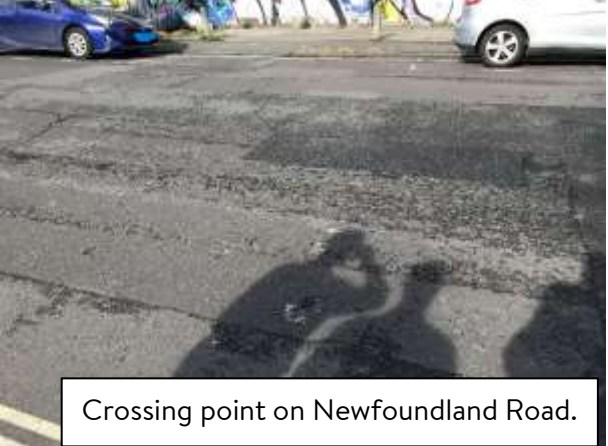
<p>Crossing point on Newfoundland Road.</p>

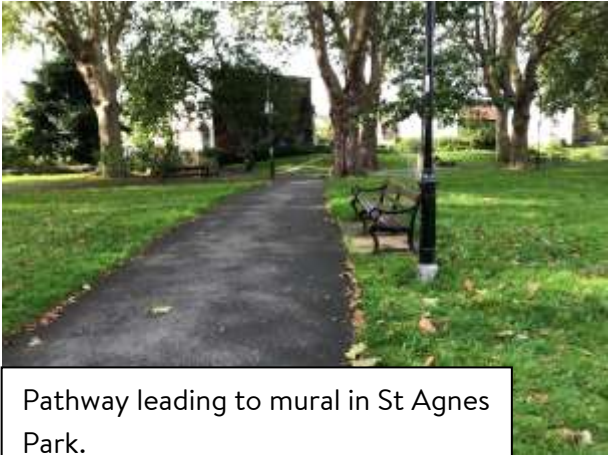
<p>St Agnes Church</p>	<p>Double metal gate at the entrance, does not fully open, clear opening width of 1160mm. The path is tarmac and is very uneven due to tree roots. Currently there is a temporary fence installed on the left with potential trip hazard due to the fence feet, which are not a good colour contrast to the path and overhanging bushes on the left.</p> <p>Cars might be parked at the end of the path, which can restrict the exit.</p>	  <p>Gateway to St Agnes Church. Uneven tarmac path.</p>
<p>St Agnes Playground</p>	<p>Follow the path on the right around to the entrance to the playground. There is a low stonewall, which can be used to rest or there are benches with armrests within the park.</p> <p>Tarmac path through the park. Some areas are uneven due to tree roots.</p>

<p>Pathway leading to mural in St Agnes Park.</p>

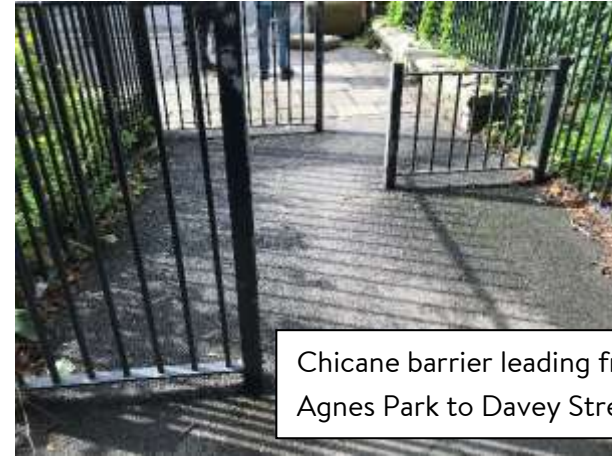
You exit St Agnes Park onto Davey Street through a chicane barrier, which is wide and allows good turning space for wheelchair users. The fence is not of a good colour contrast to the background.

Chicane barrier leading from St Agnes Park to Davey Street.

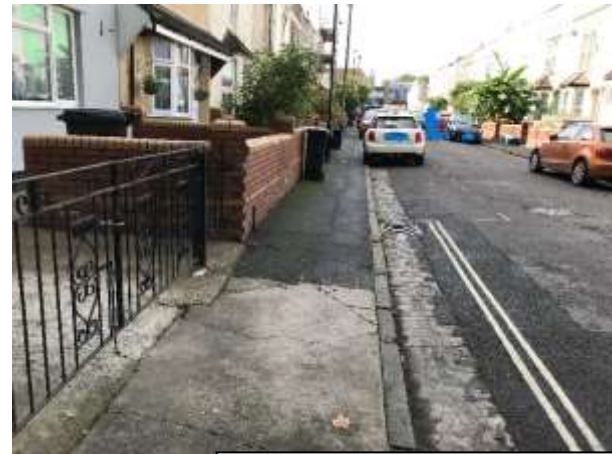
The street is paving stones which are level then becomes tarmac as you move along the street. The pavements may be restricted due to rubbish bins and vehicles parking on the pavement.

Left side pavement, Davey Street

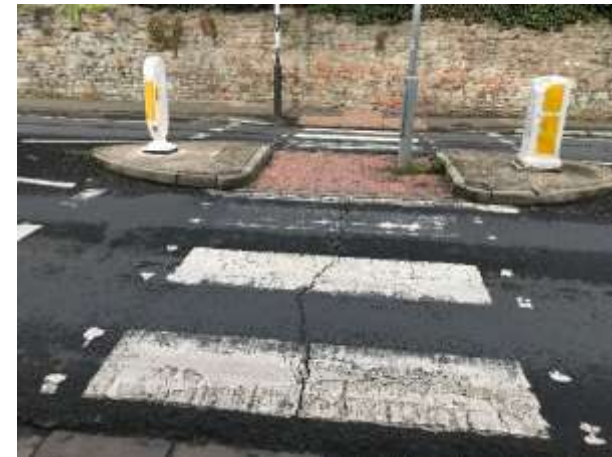
Wide tarmac path, recommend using the zebra crossing on City Road to cross to continue up Ashley Road. Flush dropped kerb and tactile indicators.

Zebra crossing on City Road, pedestrian refuge point and tactile indicators and dropped kerbs.

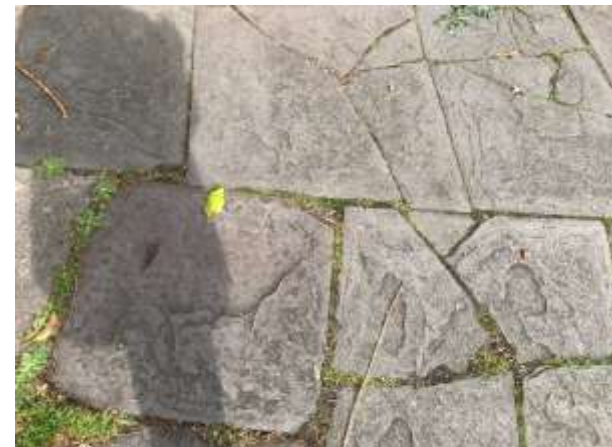
Uneven paving stones on the corner of City Road and Ashley Road and is quite steep.

Uneven paving corner of City Road and Ashley Road

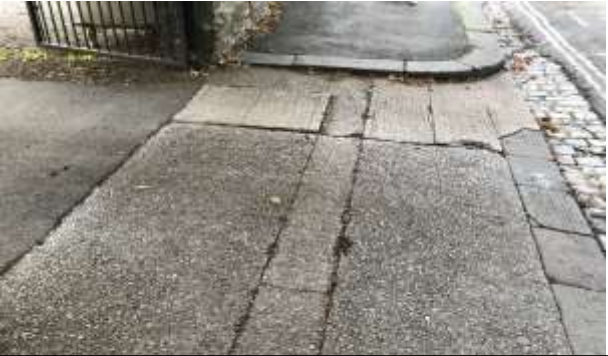
<p>No dropped kerbs or tactile indicators when crossing driveways. Kerbs not very deep but could be an issue for anyone using a manual wheelchair or for anyone visually impaired.</p>

<p>Raised kerbs crossing a driveway on Ashley Road</p>
<p>Malcolm X Centre Carpark</p>	<p>No dropped kerb or tactile indicators and no defined walkway into Malcolm X Centre carpark or through the carpark. Carpark is uneven tarmac.</p> <p>If more accessible, you can listen outside the carpark.</p>

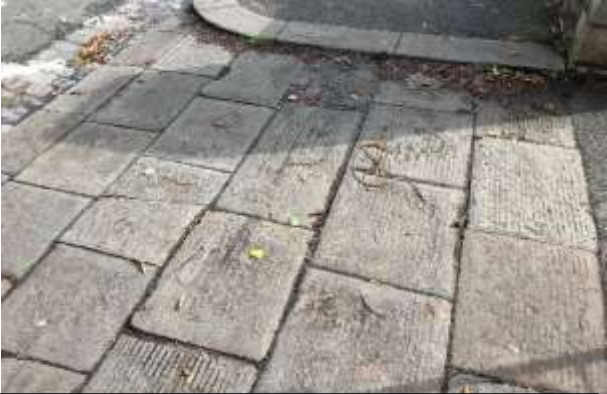
<p>Driveway is uneven flagstones.</p>

<p>Kerbs and flagstones of Malcolm X Centre Driveway</p>
<p>Ashley Road continued</p>	<p>Dropped kerbs not flush with road and no tactile indicators to cross Dalrymple Road.</p> <p>Crossing Drummond Road, flush dropped kerbs and tactile indicators however, the paving has sunk causing it to be very uneven.</p>

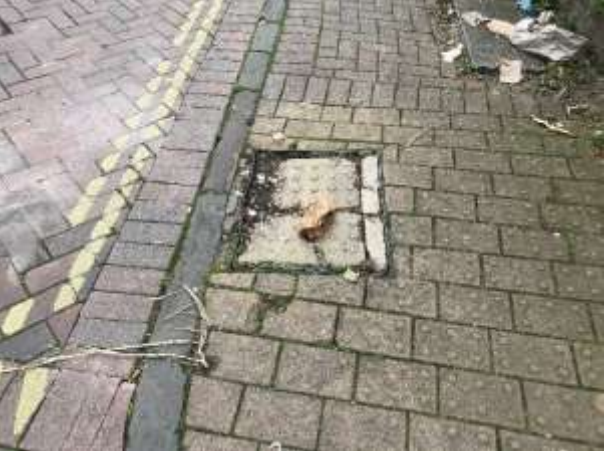
<p>Broken and uneven tactile indicators on the corner of Drummond Road.</p>

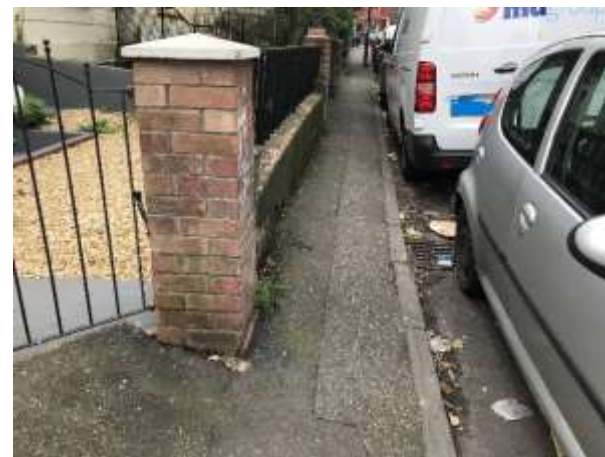
Pavement becomes very narrow at only 800mm wide, there is no dropped kerb to cross the road to the Seventh Day Adventist Church.

Narrow pavement Ashely Road leading to Brigstocke Road

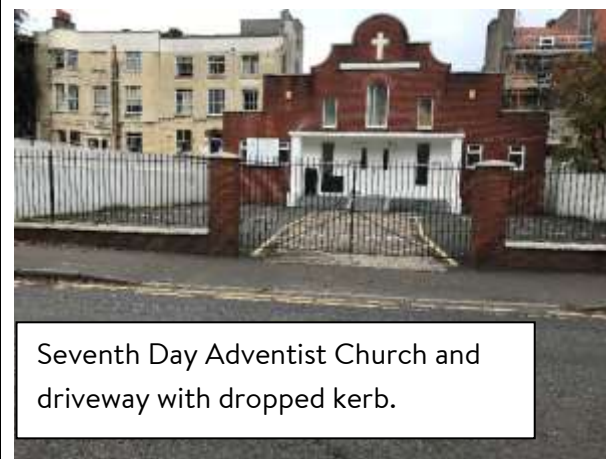
Driveway providing dropped kerb in front of the Seventh Day Adventist Church, however no dropped kerb opposite until you reach the corner of Brigstocke Road.

Seventh Day Adventist Church and driveway with dropped kerb.

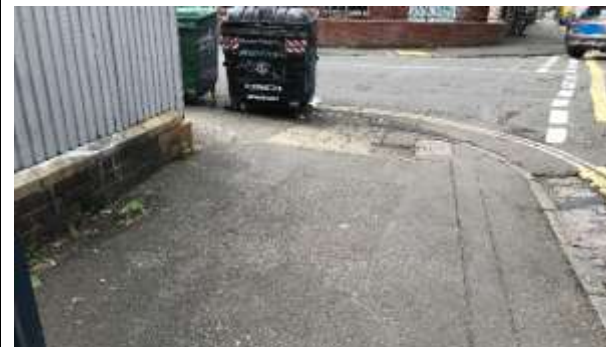
Dropped kerb and tactile indicators on corner of Brigstocke Road and Ashley Road. Pavement has sunk and is very uneven.

Corner of Ashley Road and Brigstocke Road, uneven sunken pavement on the corner.

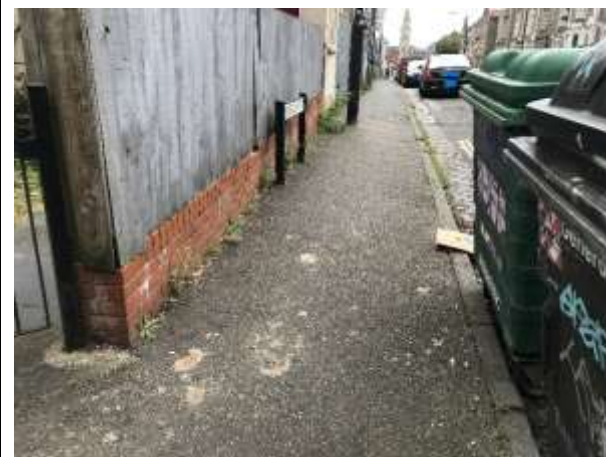
Tarmac pavement fairly good condition, slopes down towards City Road.

View down Brigstocke Road towards City Road.

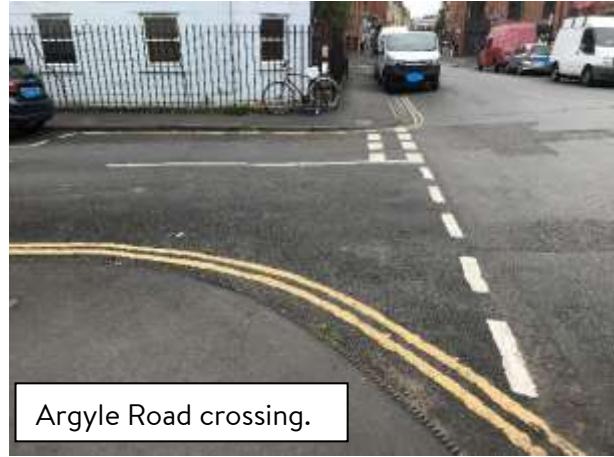
<p>Argyle Road crossing.</p>

<p>Crossing City Road</p>	<p>Excellent flush dropped kerbs and tactile indicators. No pedestrian crossing, cross with care.</p>	  <p>City Road crossing point.</p>
<p>Brigstocke Road continued.</p>	<p>Mostly tarmac pavement, road slopes down towards Portland Square.  Low kerb with no tactile indicators, kerb not flush with the road when crossing Argyle Road.</p>

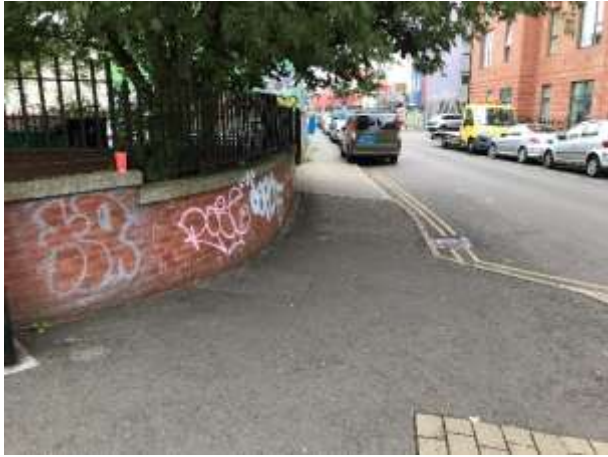
<p>Wilder Street</p>	<p>Mostly level wide tarmac path.</p> <p>No dropped kerbs on the corner of Little Bishop Street and Bishop street, recommend crossing using the flush dropped kerbs and tactile indicators to cross Wilder Street to the Inkerman (building site) and then cross Princes Street which leads to Little Bishop Street to the right.</p>

<p>Corner of Brigstocke Road and Wilder Street</p>
<p>Little Bishop Street</p>	<p>Smooth level tarmac path that leads to a lane that leads to St Pauls Park.</p>

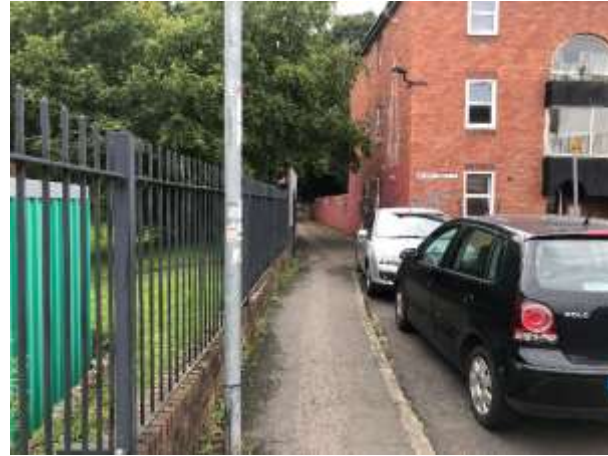
<p>Little Bishop Street and lane to St Pauls Park</p>

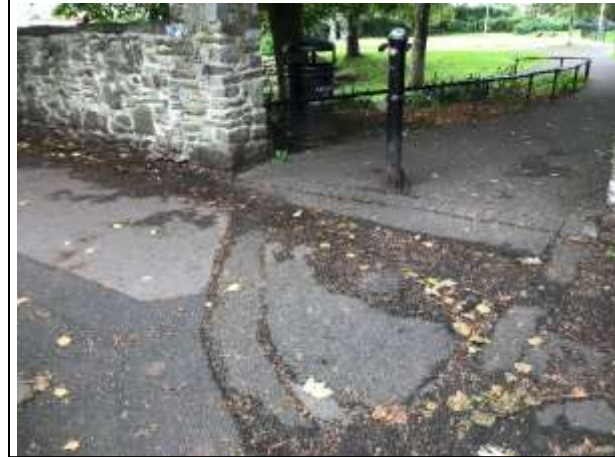
Tarmac has worn and is uneven at the entrance to the park.

Uneven tarmac path at the entrance to St Paul's Park

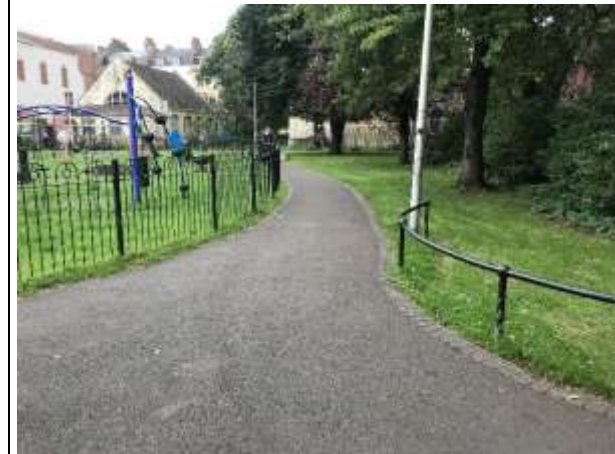
The path through the park is wide and level.

Tarmac path leading through St Paul's Park

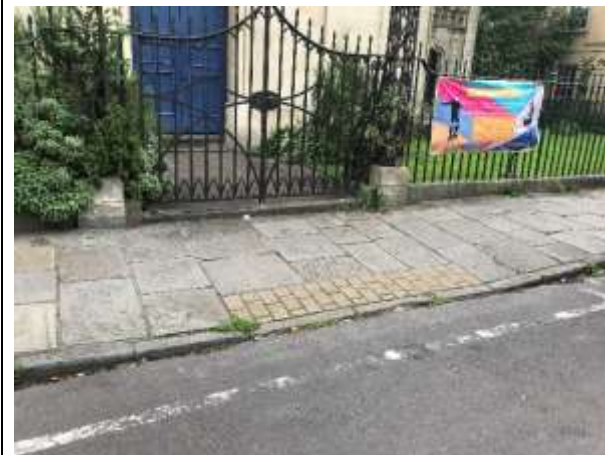
Outside Circomedia, leading to the park there is a dropped kerb, which is not, flush there are tactile indicators.

Dropped kerb outside Circomedia.

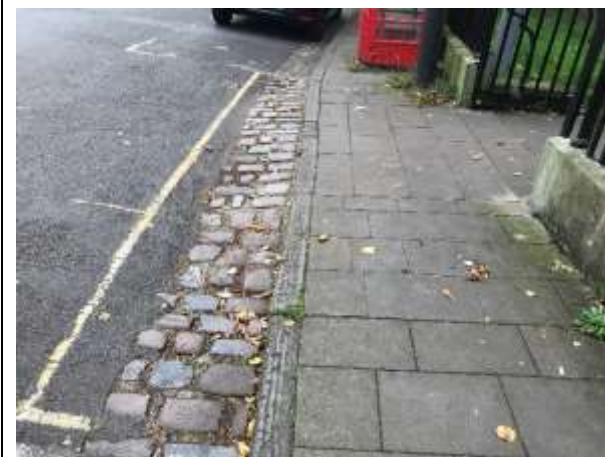
An uneven cobble stone ramp instead of a dropped kern to access the pavement and park in the middle of Portland Square. There are no tactile indicators.

Cobble ramp, Portland Square

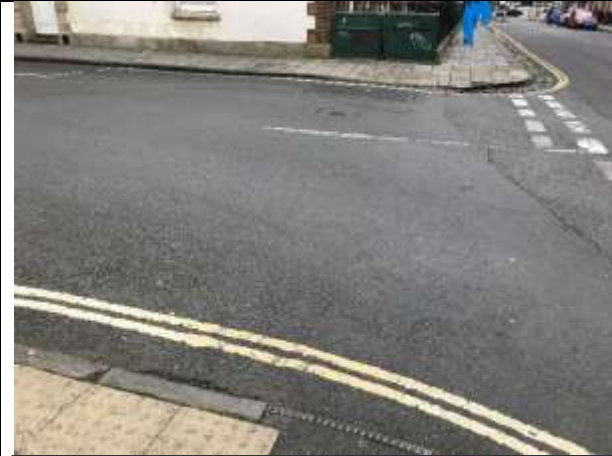
To cross Wilson Street flush dropped kerb and tactile indicators as you leave Portland Square, the pavement is very uneven on the other side of the road.

Wilson Street crossing point, dropped kerbs, tactile indicators and uneven paving
